Evaluation Report

23

B & K Bale Karrier 815

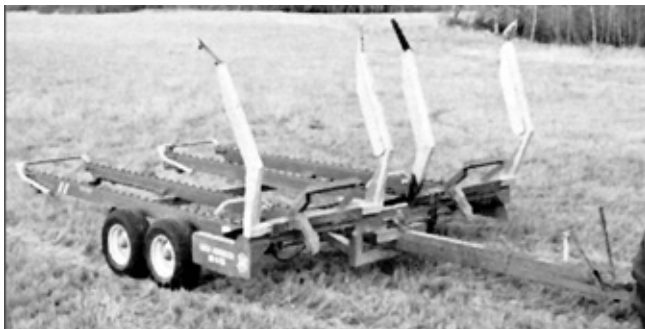
Figure 1. B & K 815 in Transport Position.

The B & K Bale Karrier 815 (Figures 1 & 2) is a self loading, non-tilting, twin bed, four wheel trailer with two axles, for use with tractors 46 kW (60 hp), or larger, equipped with dual hydraulics. Bales are picked up either on the left or right side of the tractor with hydraulic forks which place bales crossways on either bed.

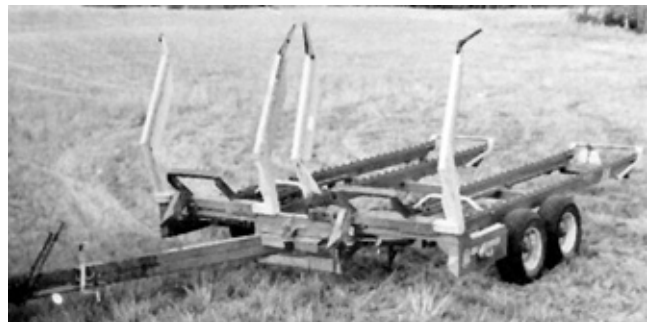
Figure 2. B & K 815 With the Tongue Positioned for Loading the Left Bed.

Loading: The B & K 815 is placed in field loading position by swinging the tongue either to the right or to the left depending on which bed is to be loaded first. With both forks in the raised position the tongue latch is unlocked with a rope and by making a sharp turn, the tongue slides to the appropriate side and locks in position.

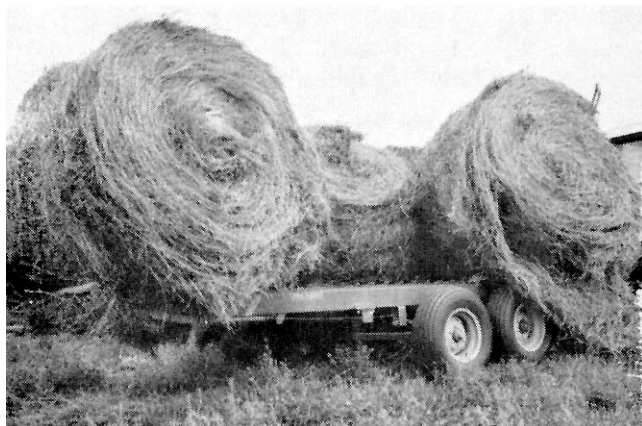
skewed sideways and were placed at an angle on the bedrails. Skewed bales occasionally toppled between the beds as more bales were loaded, (Figure 3). Tapered bales also sometimes fell between the beds as they moved rearward on the transfer chains, necessitating a tractor and front end loader to remove them. A centre guard rail, installed between the two beds, would eliminate this problem.

Figure 3. Skewed Bale Wedged Between the Two Beds.

1. Modifications to prevent bales from falling between the two beds.
2. Modifications to eliminate pickup fork cylinder shaft failure.
3. Providing a Slow-Moving Vehicle sign as standard equipment.
4. Modifying the pickup fork flipper wedges to make flipper action more positive.
5. Modifying the pickup arm tips to eliminate tip failure.
6. Providing a tailgate position indicator.
7. Modifications to prevent the load from sliding rearward, due to free rotation of the rail chains, when loading up steep slopes.
8. Modifications to eliminate wheel toe-out with a loaded wagon.

1. A bar has been installed as standard equipment to prevent bales from falling between the two beds.
2. The diameter of the pickup fork cylinder shaft has been increased.
3. A bracket for a Slow-Moving Vehicle sign has been provided as standard equipment.
4. This recommendation is under investigation.
5. The pickup arm tips have been redesigned and strengthened to eliminate tip failure.
6. A tailgate position indicator is available as an option in 1977.
7. This recommendation is under investigation.
8. The load points have been redesigned and repositioned to give proper load distribution and prevent wheel toe-out.

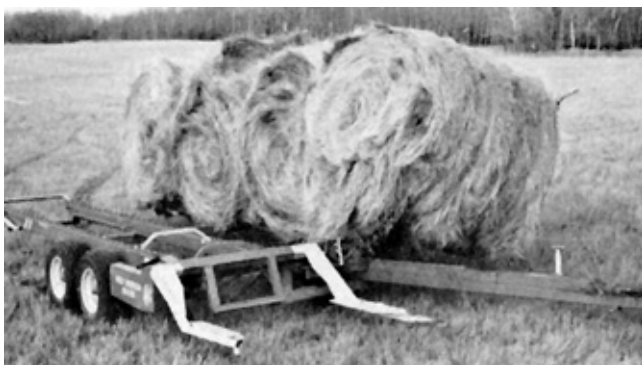
The fourth bale is held against the load on the pickup fork in half raised position. This allows the tongue to be repositioned to the loaded side enabling the opposite bed to be loaded in the same manner (Figure 4).

Figure 4. B & K 815 With the Left Bed Fully Loaded.

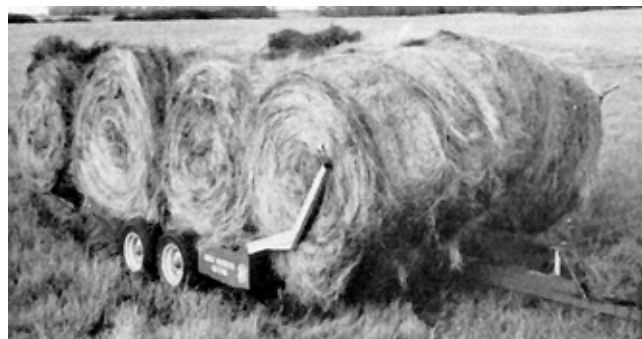
Transporting: When fully loaded the tongue is moved to centre position between the two beds allowing the mover to tow directly behind the tractor (Figure 5). For travel on public roadways a Slow Moving Vehicle sign had to be attached to the rear as none was supplied with the B & K 815. A suitable location for an SMV sign is on the tailgate (Figure 6).

Figure 5. B & K 815 Fully Loaded in Transport Position.

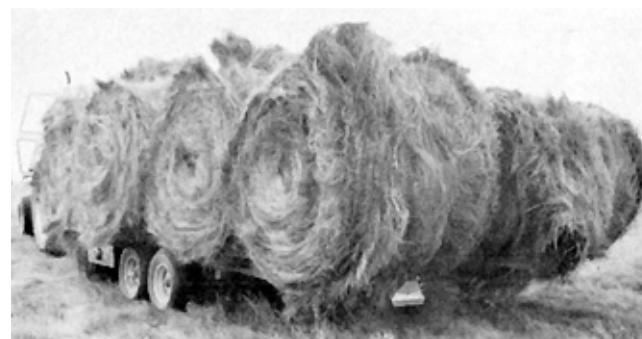
Figure 6. SMV Sign Mounted on Rear Tailgate.

The B & K 815 was not equipped with a Slow-Moving Vehicle sign or bracket. A permanently affixed sign is required as normal operation involves transport on public roads.

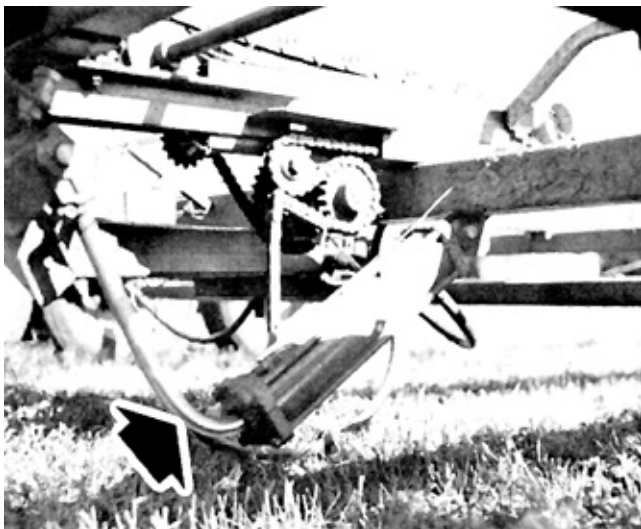
cylinders apply their full force against the load. The rail chains are protected with a shear pin, however, attempting to lift the fork bends the shaft on the fork lift hydraulic cylinder (Figure 7) before the tractor hydraulic system relieves. Three fork cylinder shafts bent during the test. Modifications to prevent lift fork cylinder shaft failures are required. A tailgate position indicator would also be useful.

Figure 7. Pickup Fork Cylinder Shaft Failure.

Pickup Fork Cylinder: The cylinder shaft bent and was replaced three times. In two cases the operator assumed that the tailgate was down and attempted to unload a bed. The resistance of the load caused the fork cylinder shaft to bend. In the third case the shaft bent either while in loading the fourth bale or during transport from the field. Modifications to eliminate the possibility of lift cylinder shaft bending should be considered.

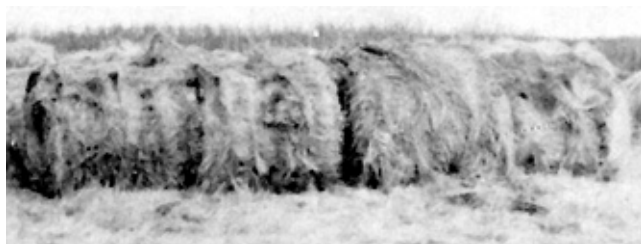
The B & K 815 could only be unloaded from the rear. This placed bales in two rows (Figure 8) about 300 mm (1 ft) apart and with the circumferences of the bales touching in each row (Figure 9). It was difficult to maintain uniform bale spacing due to lack of control and poor visibility.

Figure 8. Two Pairs of Rows Placed With the B & K 815.

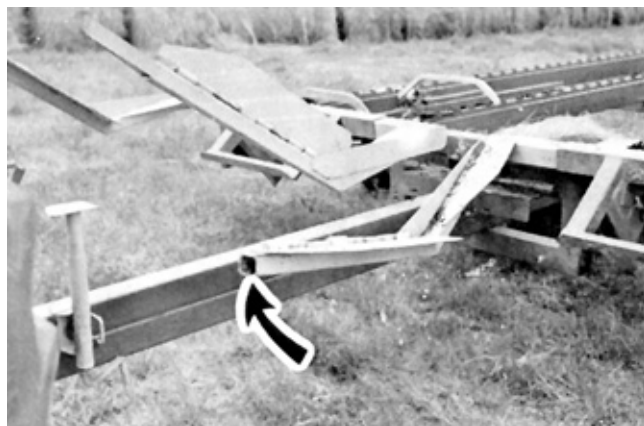
Pickup Arm Tip: The pickup fork tine tip broke off when the fork accidentally dug into the ground while loading on a hilly field.

Figure 10. Broken Tip on Pickup Fork Tine.
